1635 - Gleniffer Brae, Keiraville
Conservation Management Plan Review
August 2016

Project: GLENIFFER BRAE, KEIRAVILLE

Version	Date	Document	Conservation Management Plan Review
1		Status	DRAFT
		Author	Jennifer Hill Director, Registered Architect 4811
		Verification	Elizabeth Gibson Associate, Senior Consultant

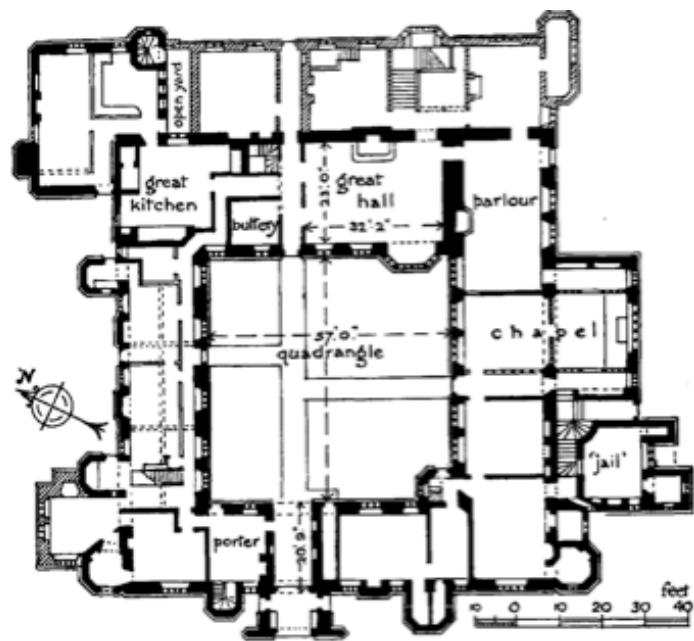
Figure 2.3	No Date	Plans of Compton Wynnyates House	A History of the County of Warwick, Vol 5, Kington Hundred, 1949
------------	---------	----------------------------------	--

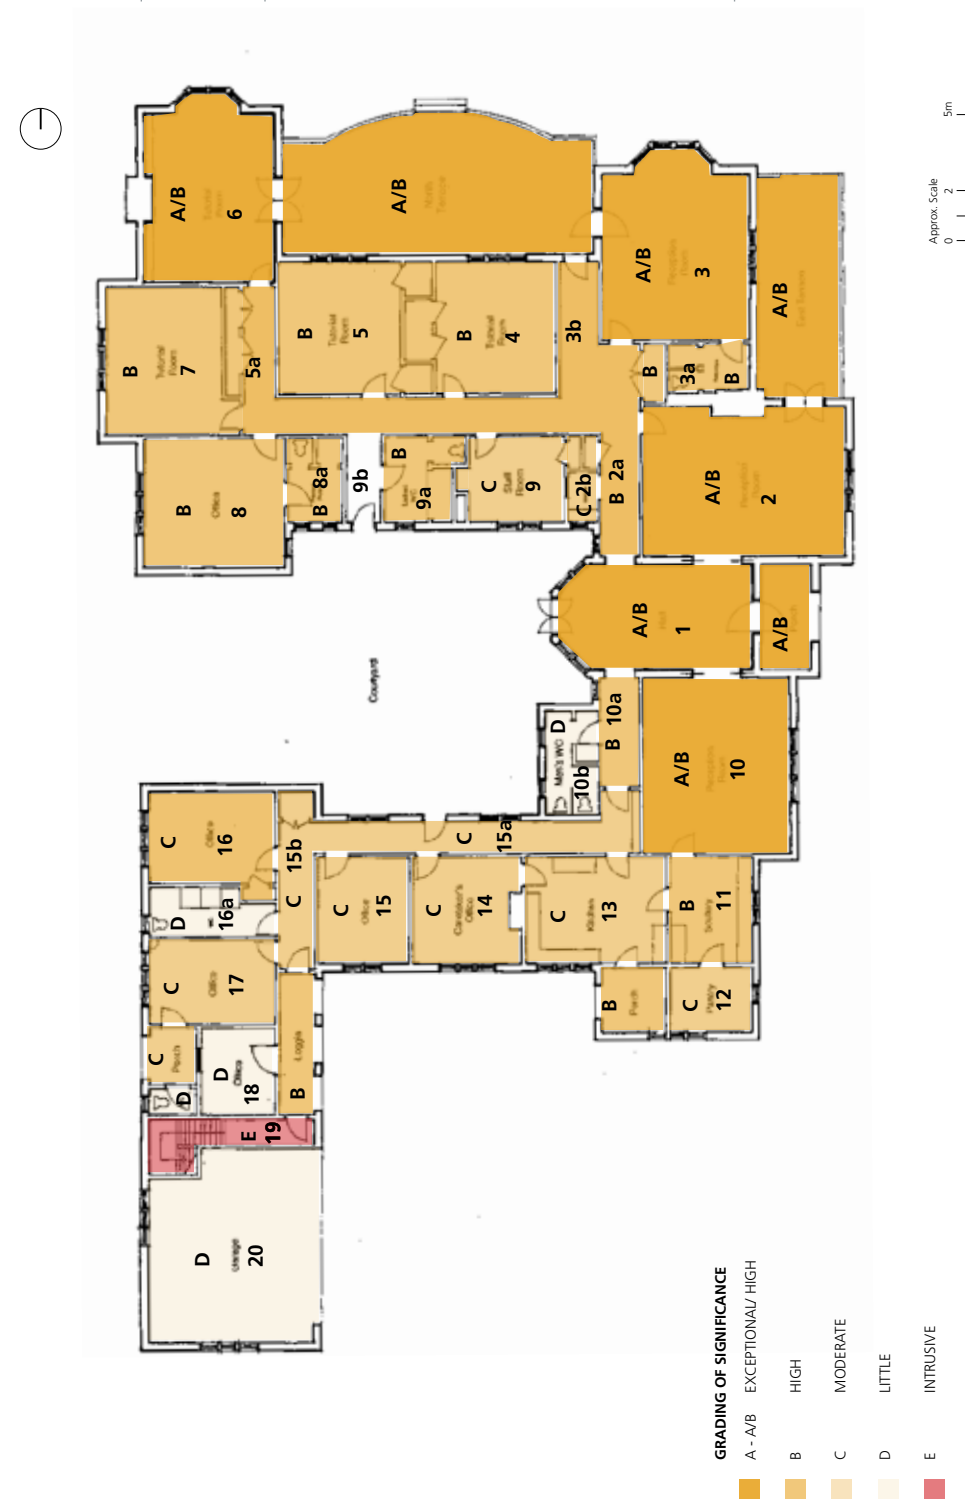
Figure 4.1 2016 Grading of Significance - Plans Architectural Projects / Tropman & Tropman

The following diagrams provide a grading of significance of the site, exterior and interior.

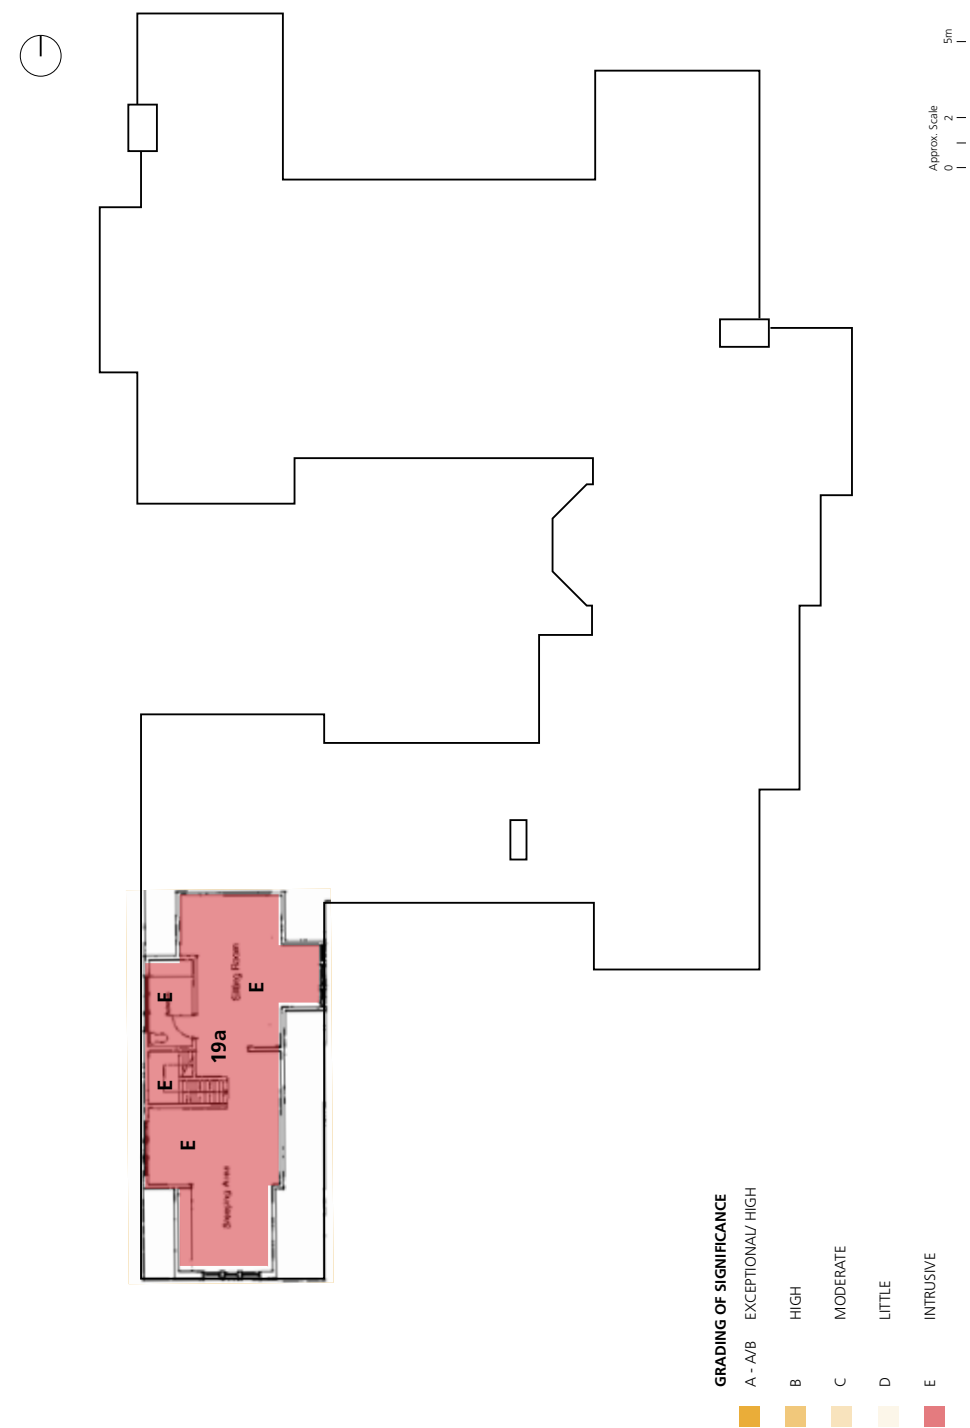
Figure 4.2

Grading of Significance - Plans

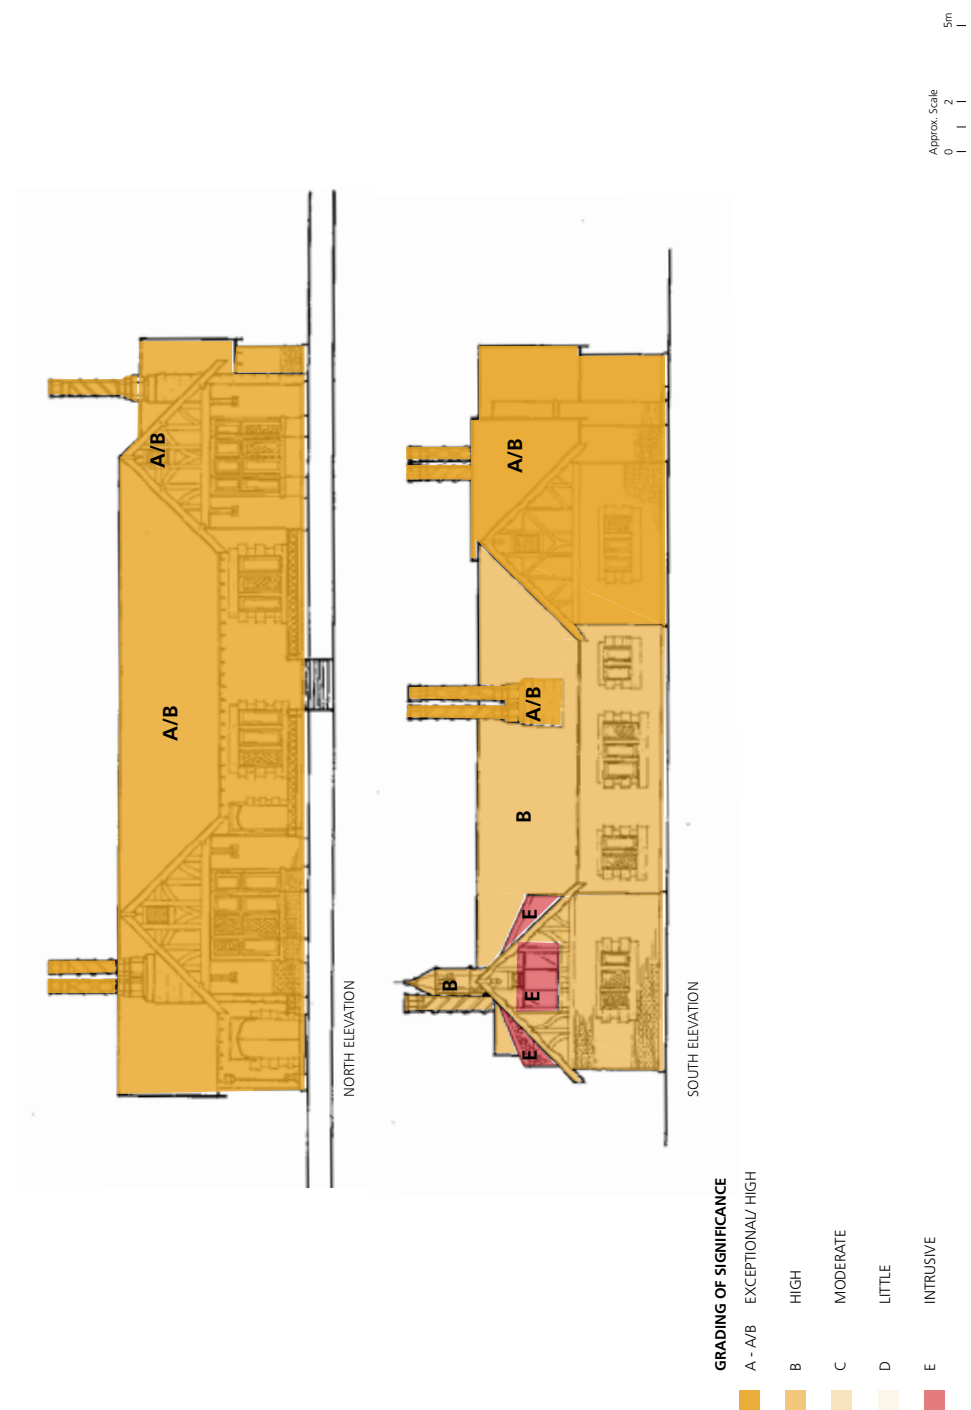
Figure 4.3

Grading of Significance - Elevations

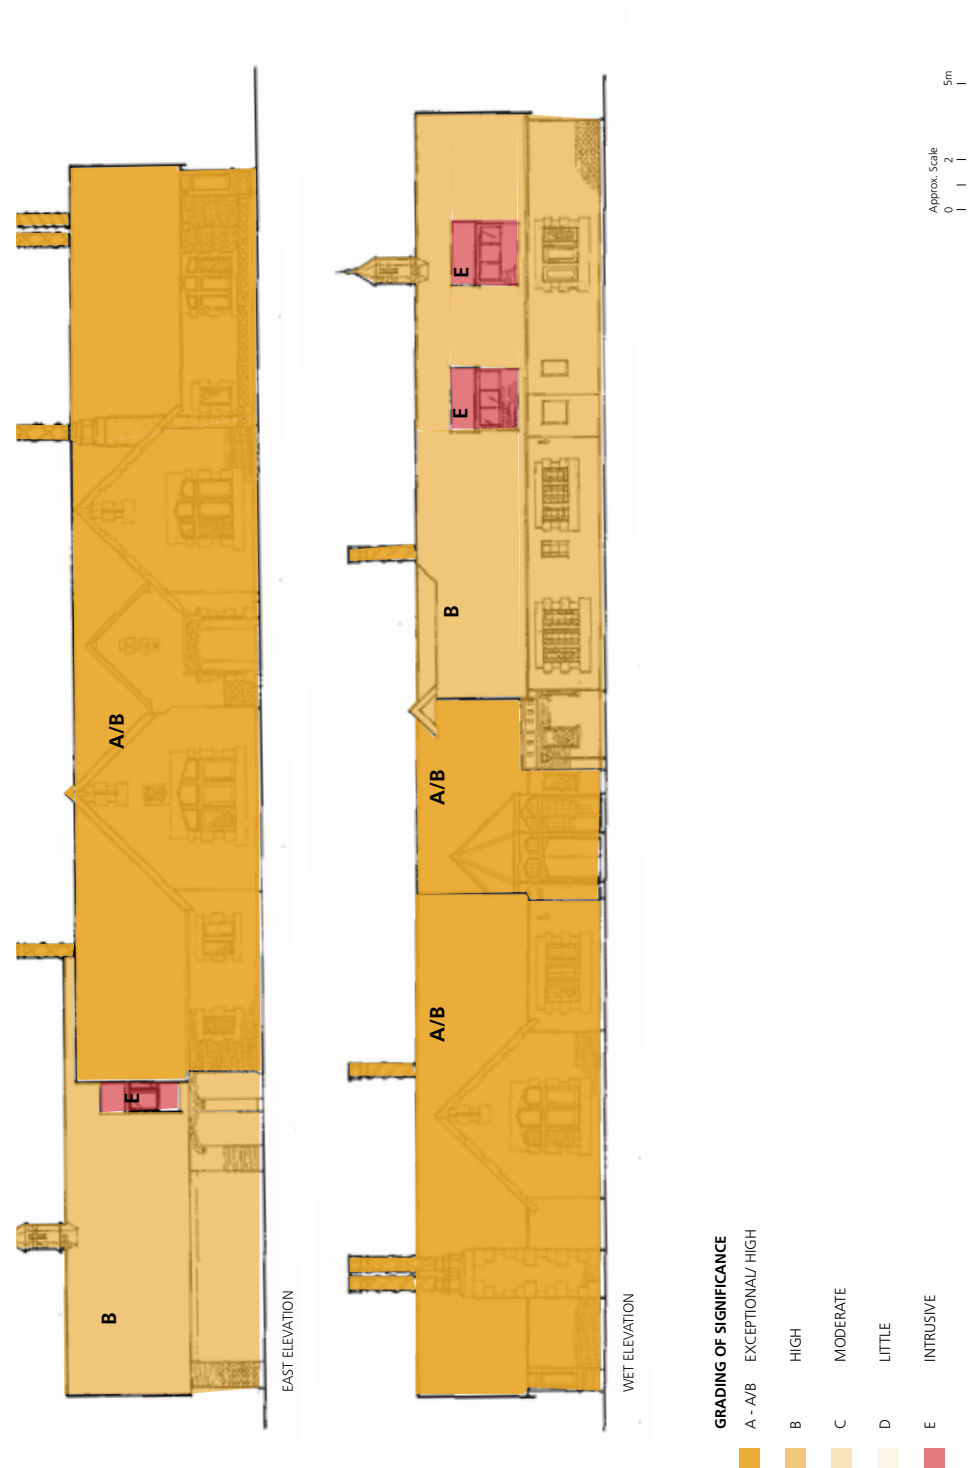
Figure 4.4

Grading of Significance - Elevations

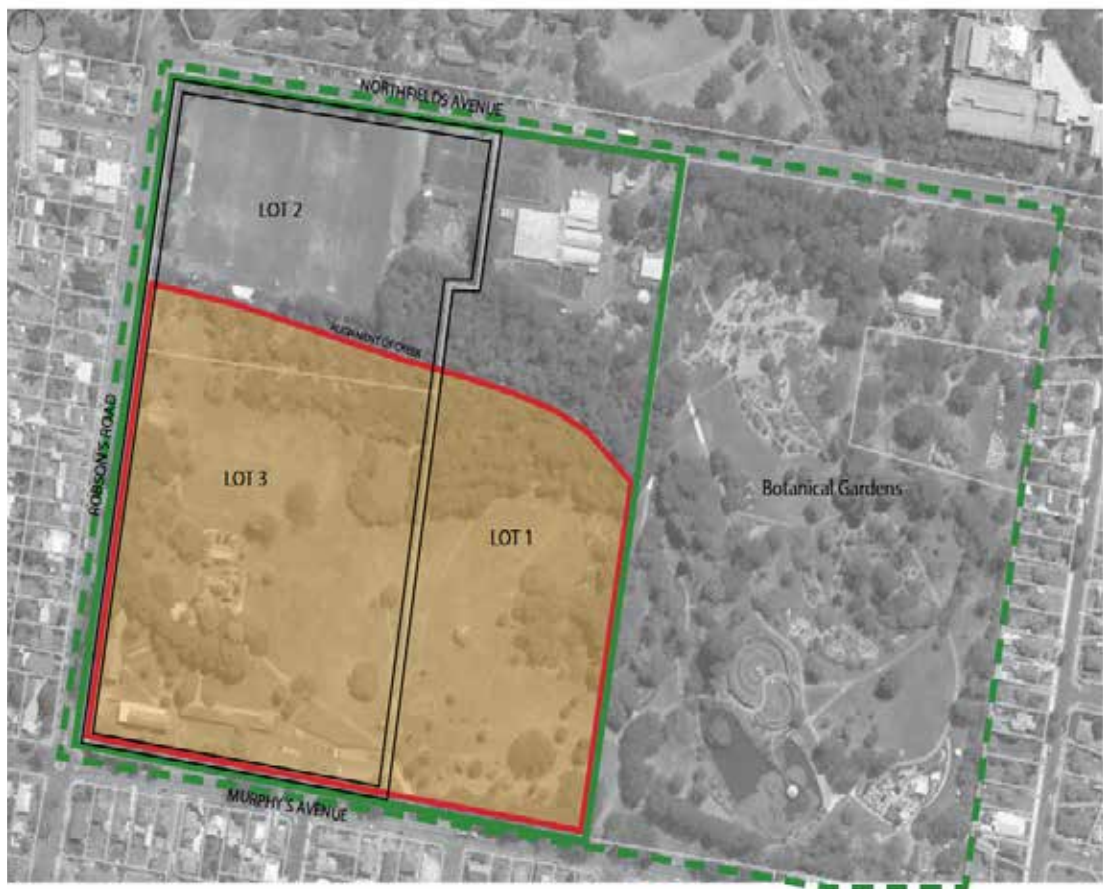
Figure 4.11	2016	Proposed Heritage Curtilage	Architectural Projects / SIX maps
-------------	------	-----------------------------	-----------------------------------

It is recommended that the curtilage of Gleniffer Brae house and grounds include all of Lot 3 and part Lot 1 and 2, The proposed curtilage is defined to the north by the creek, the east by the eastern boundary of Lot 1, to the south by Murphy Avenue and to the west by Robsons Road.

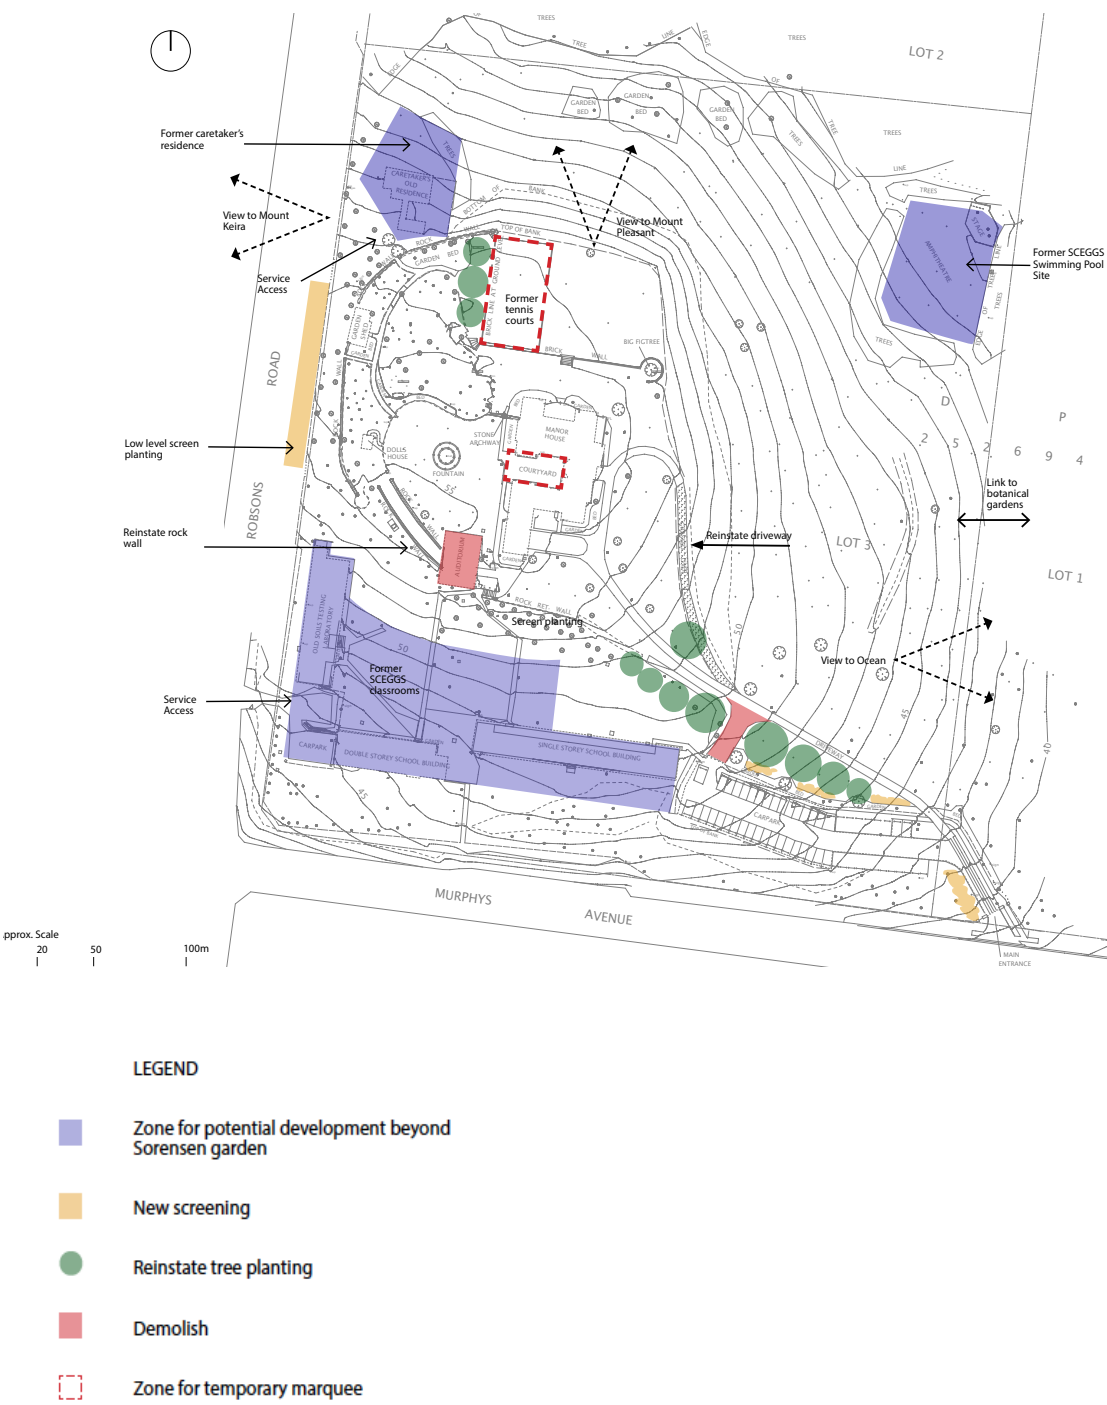
Figure 5.1 | 2016 | Constraints and Opportunities | Architectural Projects / Wollongong Council
